Certified Arboricultural Assessment

750 SE 8th Ave
Hillsboro, Or 97123

RE: Overall statue viability – Chief Kno Tah

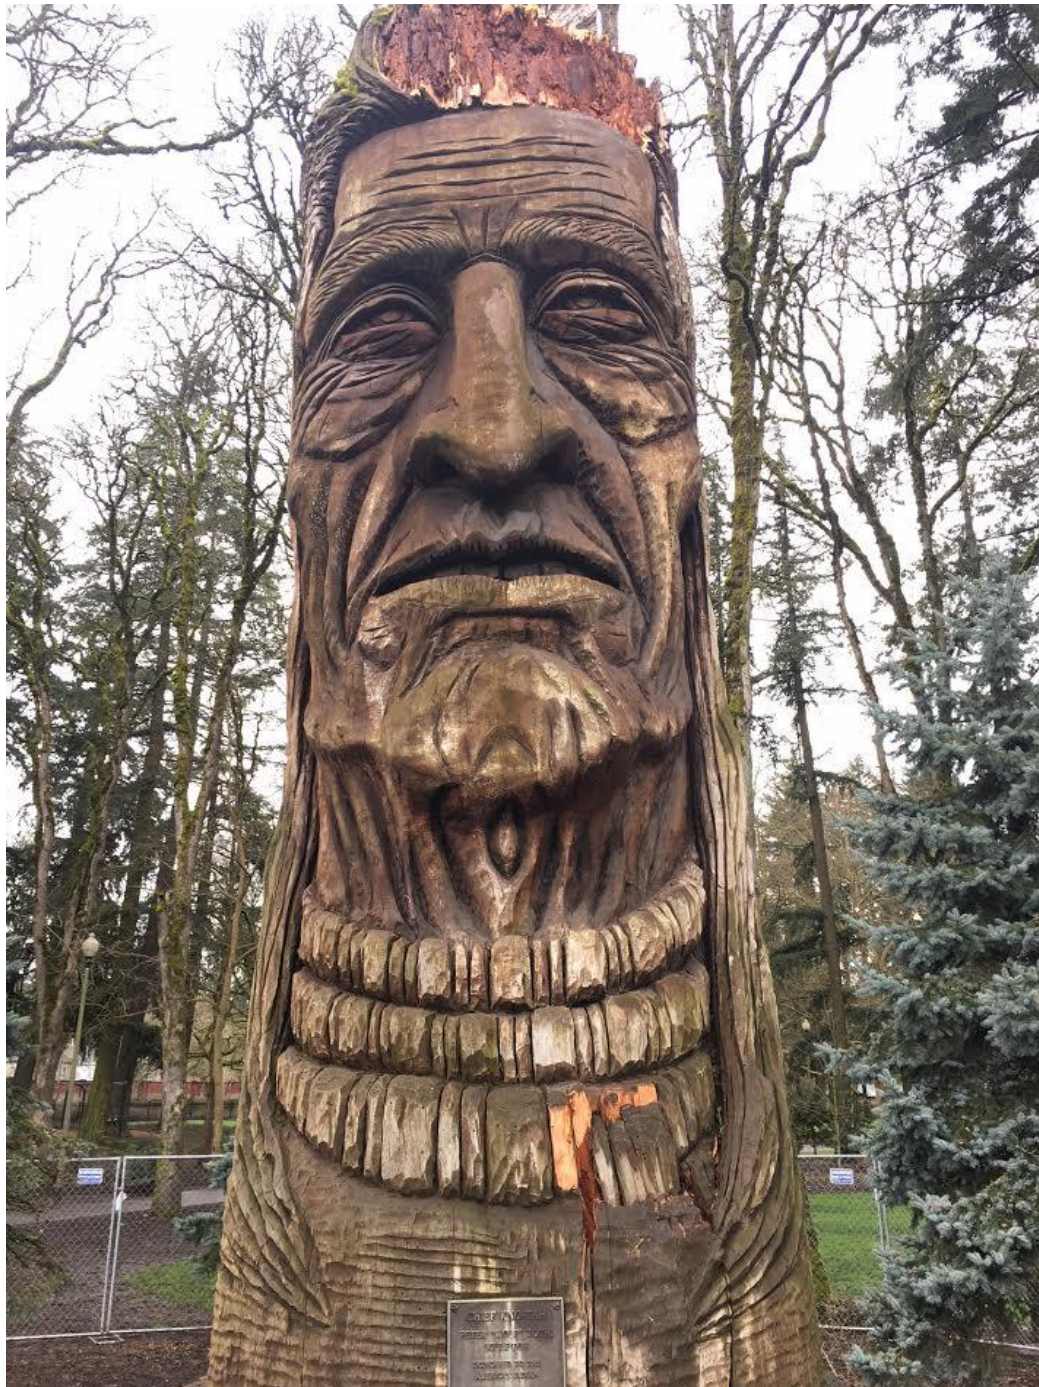
Statue looks to approx. 25' tall and 6' in diameter. Statue shows past feather failure along with recent damage from adjacent tree failure hitting the statue on top and at the base. The recent damage has exposed internal wood showing that rate of decay is severe. Wood is punky where exposed which means the strength and structural stability is suspect. Severe punk wood (as shown in photo on forehead) typically will provide little to no structural support. Statue is now seated on its base in an awkward position probably due to strike from adjacent tree failure as well as lack of statues structural integrity.

Above: Chief showing damage to at upper crown and further damage near lower base

In the short term, I recommend a fence be placed around the statue at a safe distance that no harm could come if the base were to fail.

In the long term (greater than 12 calendar months), it is of my opinion that the statue be removed for safety as failure is probable due to the existing condition of statue and its lack of structural wood integrity.
